Restoring the UMD Heliostat

The purpose of my project is working to fix the 60-year old Helioscope at the UMD observatory.

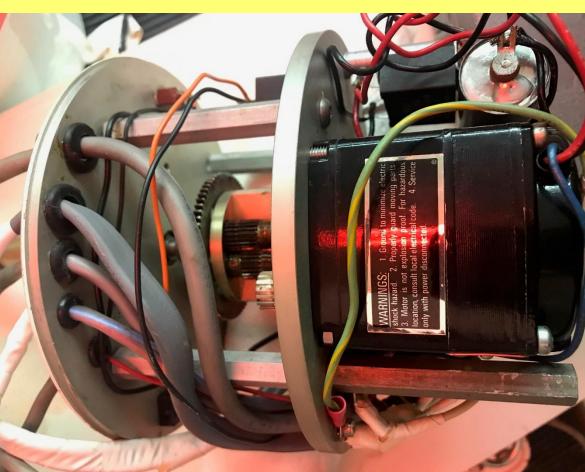
Uncovered Control Hub

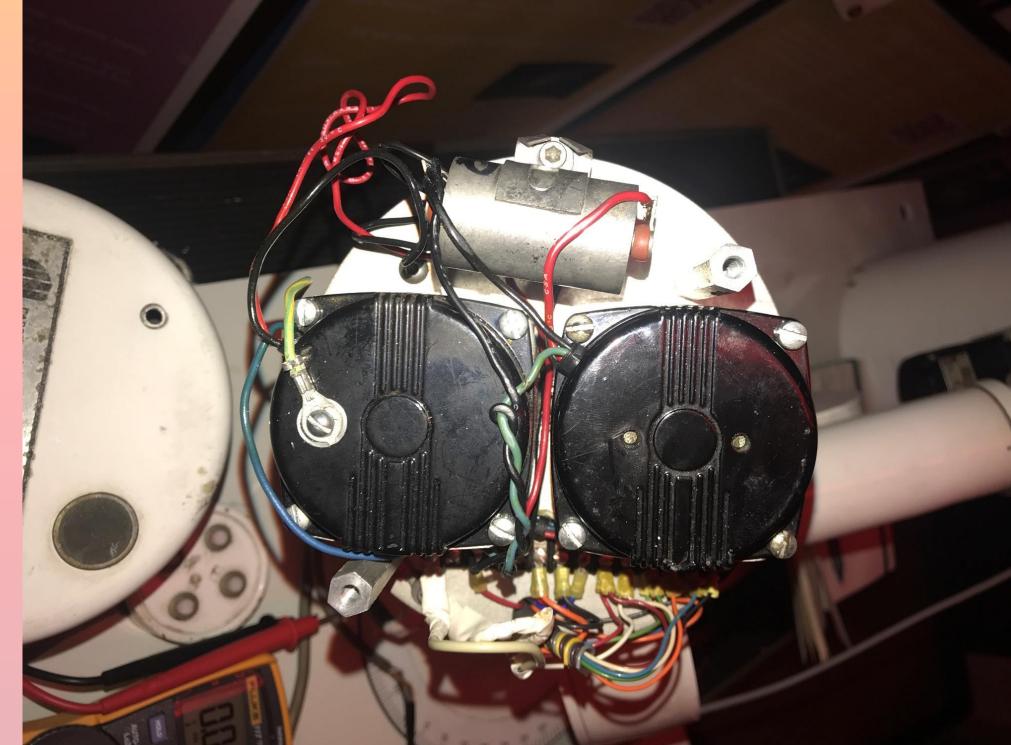
2 Motors, Capacitor and electrical circuit hub

- Soldered Front motor wires
 back together
- Created Wire Diagram with Volt and Amp measurements
- Replaced dead switch with new LED switch

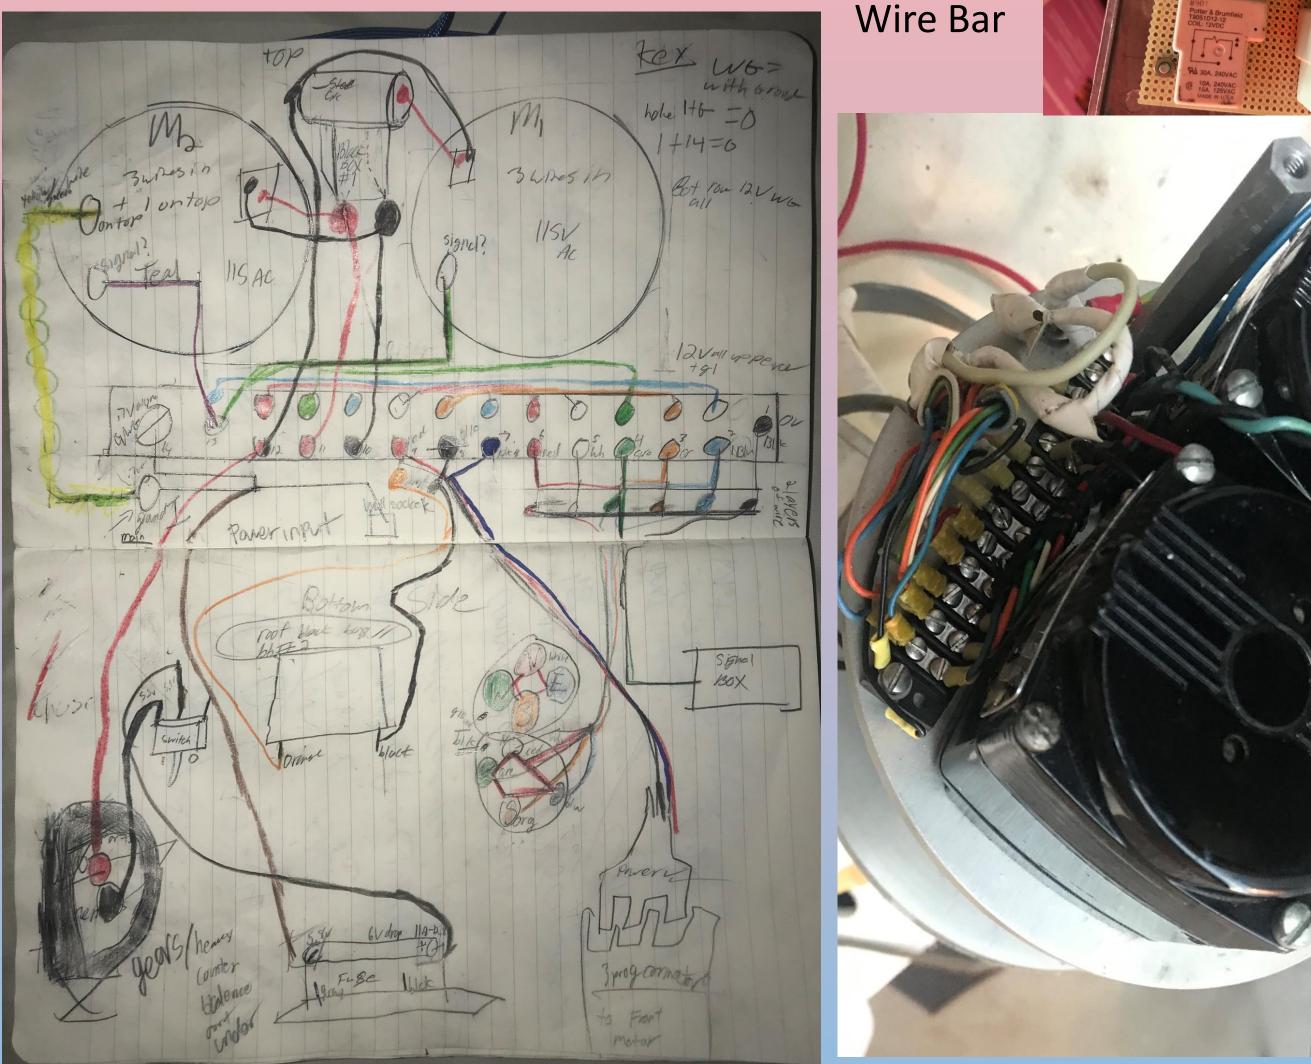
Through the process of classifying each component I learned a great deal about Hand Drawn Circuit Diagram
