8 Inch Astrograph Repair

The Observatory

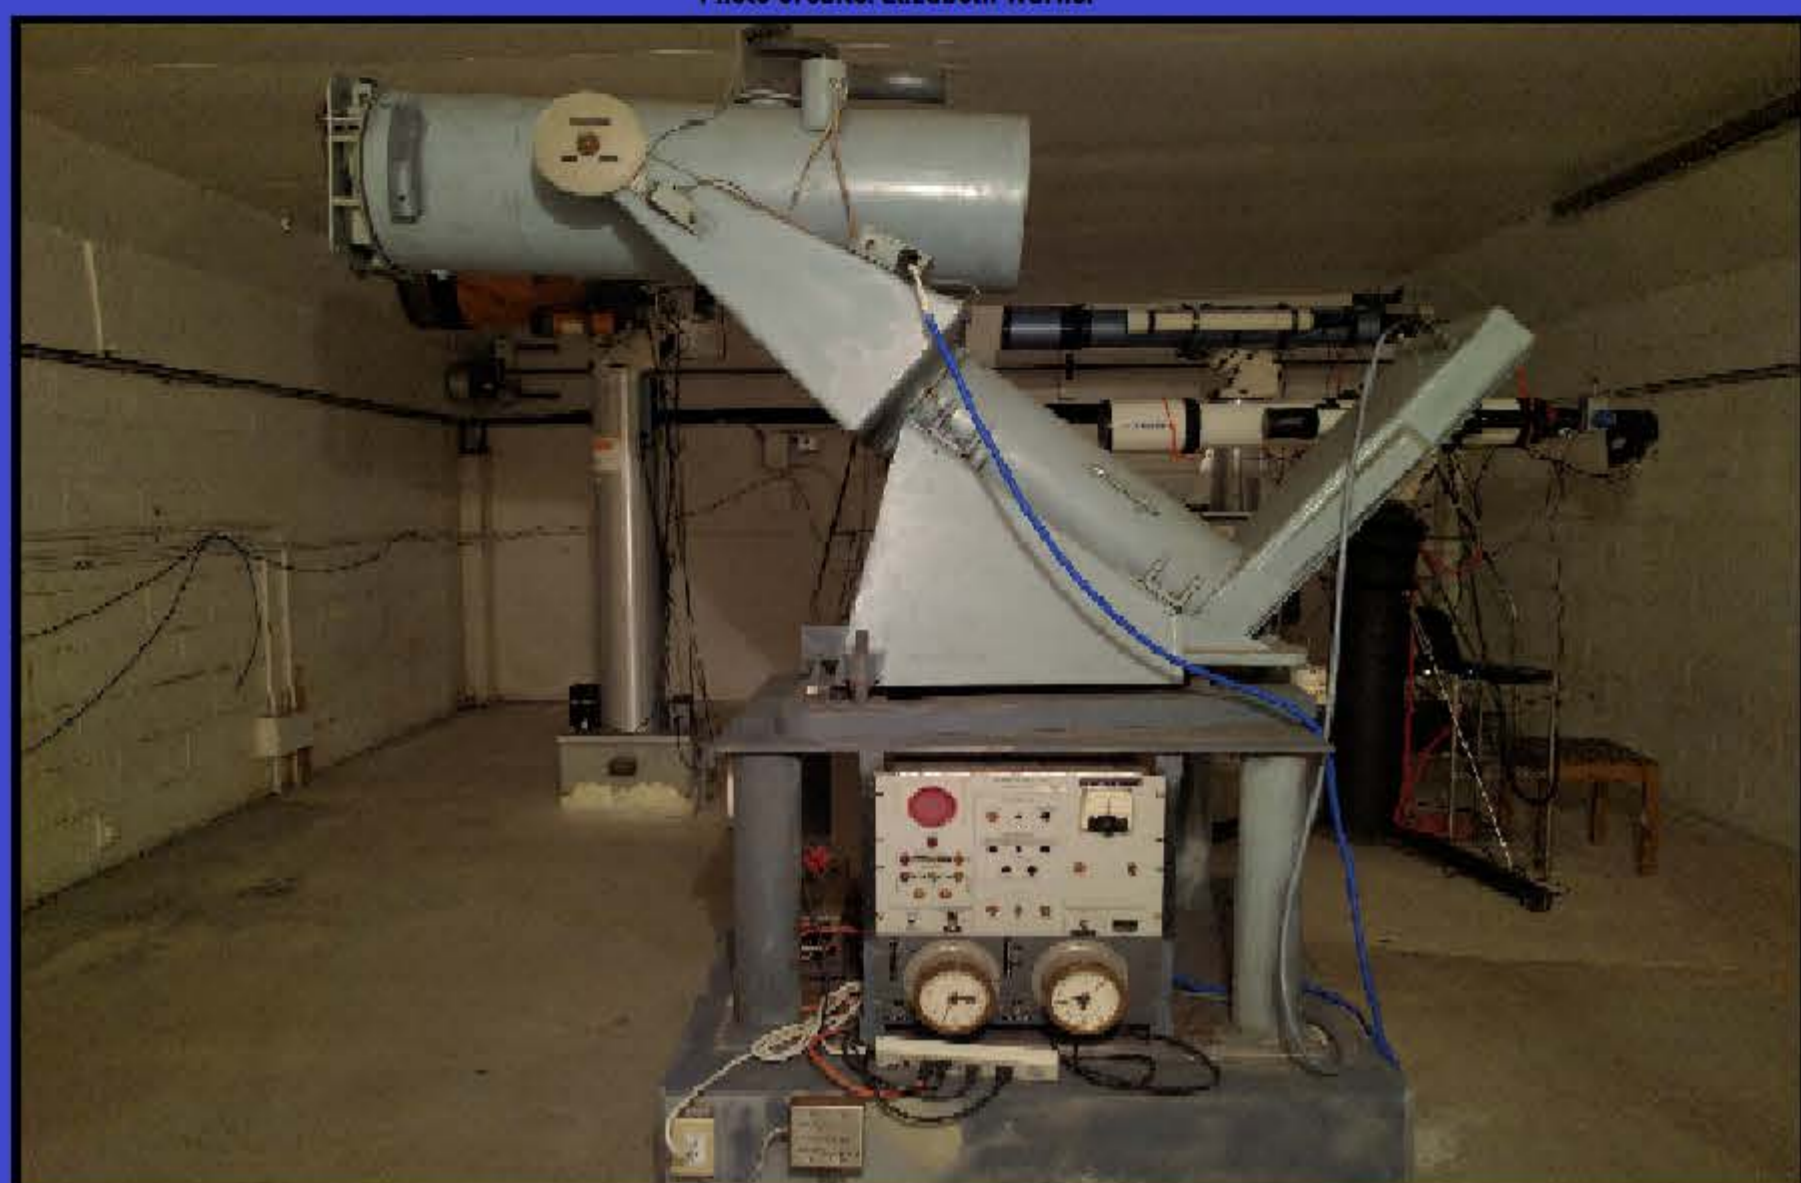
Originally used to track and photograph satellites in orbit around Earth, this 8 inch astrograph was sent to the University of Maryland Observatory after it was no longer needed at NASA. At the observatory, its two motors were once used to keep a steady look at one point of the moving night sky, until the small motor stopped working years ago.

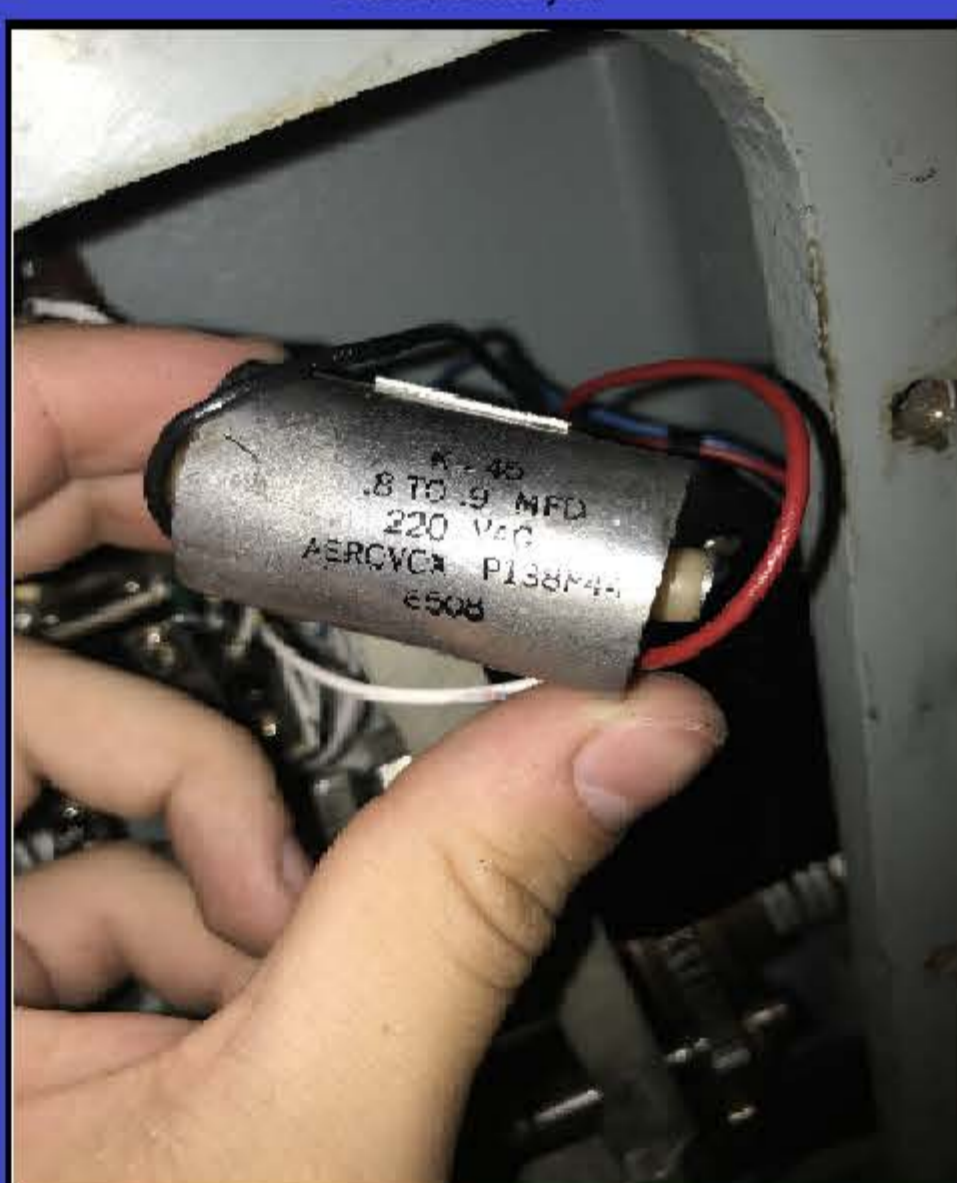
Another issue I thought the astrograph may have faced was one with the capacitor. The capacitor allows for charge to be stored for a later time in a circuit. If the capacitor was broken, no charge would be reaching the small motor at all, which would clearly result in the motor not working, so I replaced it during my repairs.

I successfully replaced the capacitor in the astrograph, however it was seemingly not the issue with the motor. I have not finished replacing the relays to see if those are the issue, since I have not been able to return to campus and finish the repairs.

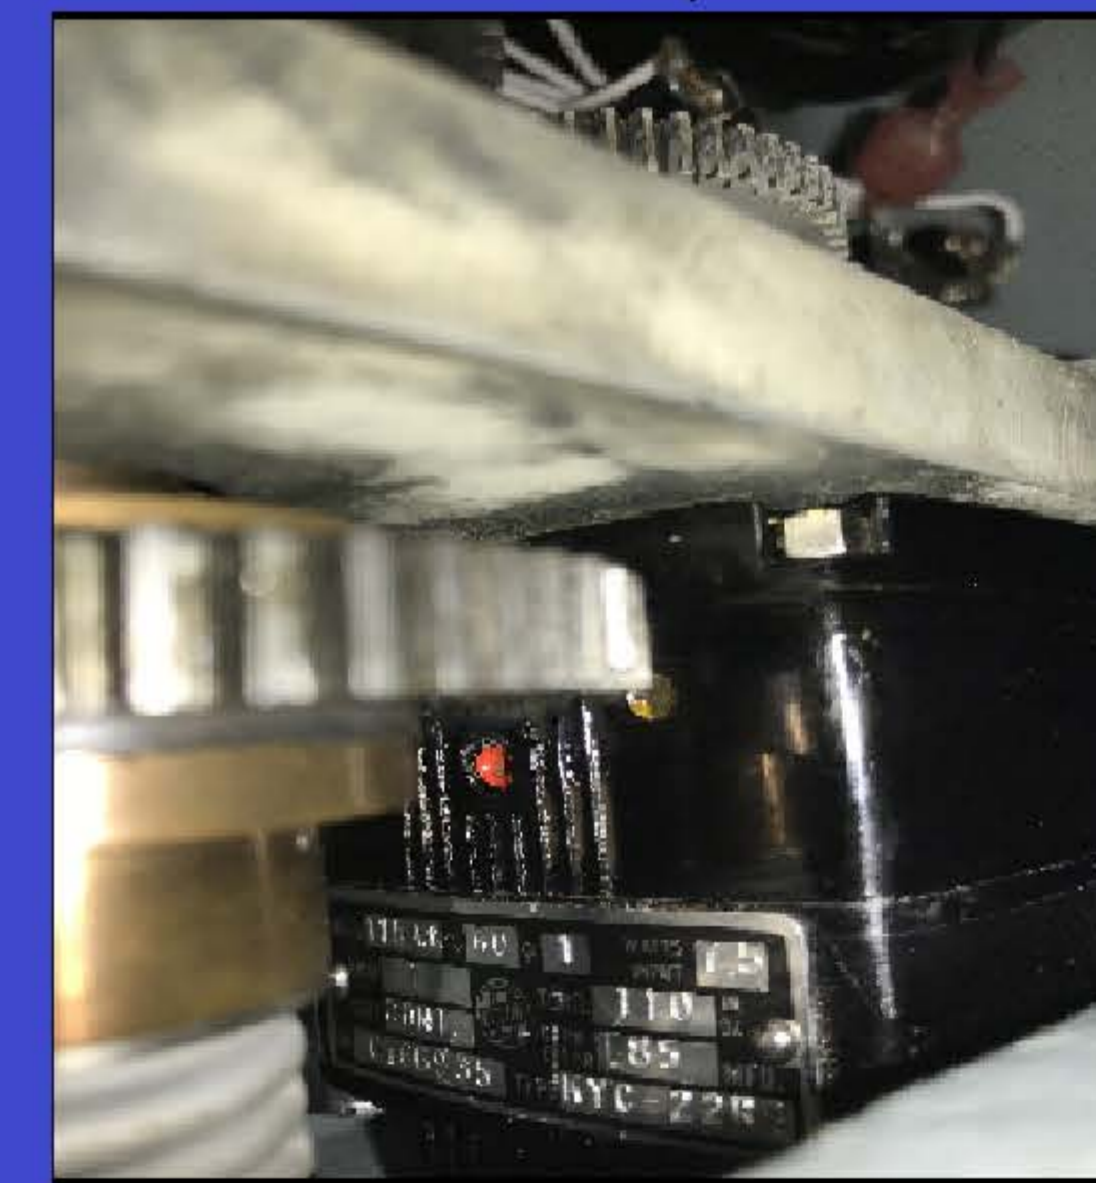
This is the small motor itself. With a speed of 1 revolution per minute, it was a very slow, which is very good for keeping up with the movement of the night sky due to Earth's rotation. After new outlets were added to the observatory, the motor stopped functioning completely, leaving only the large, faster motor working.

In the future, I hope to finish replacing the relays to see if that fixes the problems with the motor. If that is not the issue, I would see if the other relays inside the astrograph could be the problem. If all else fails I would try to replace the entire small motor in the astrograph.
