CARMA Memorandum Series #17 [1]

Stability of BIMA antenna positions

J. R. Forster

October 23, 2003

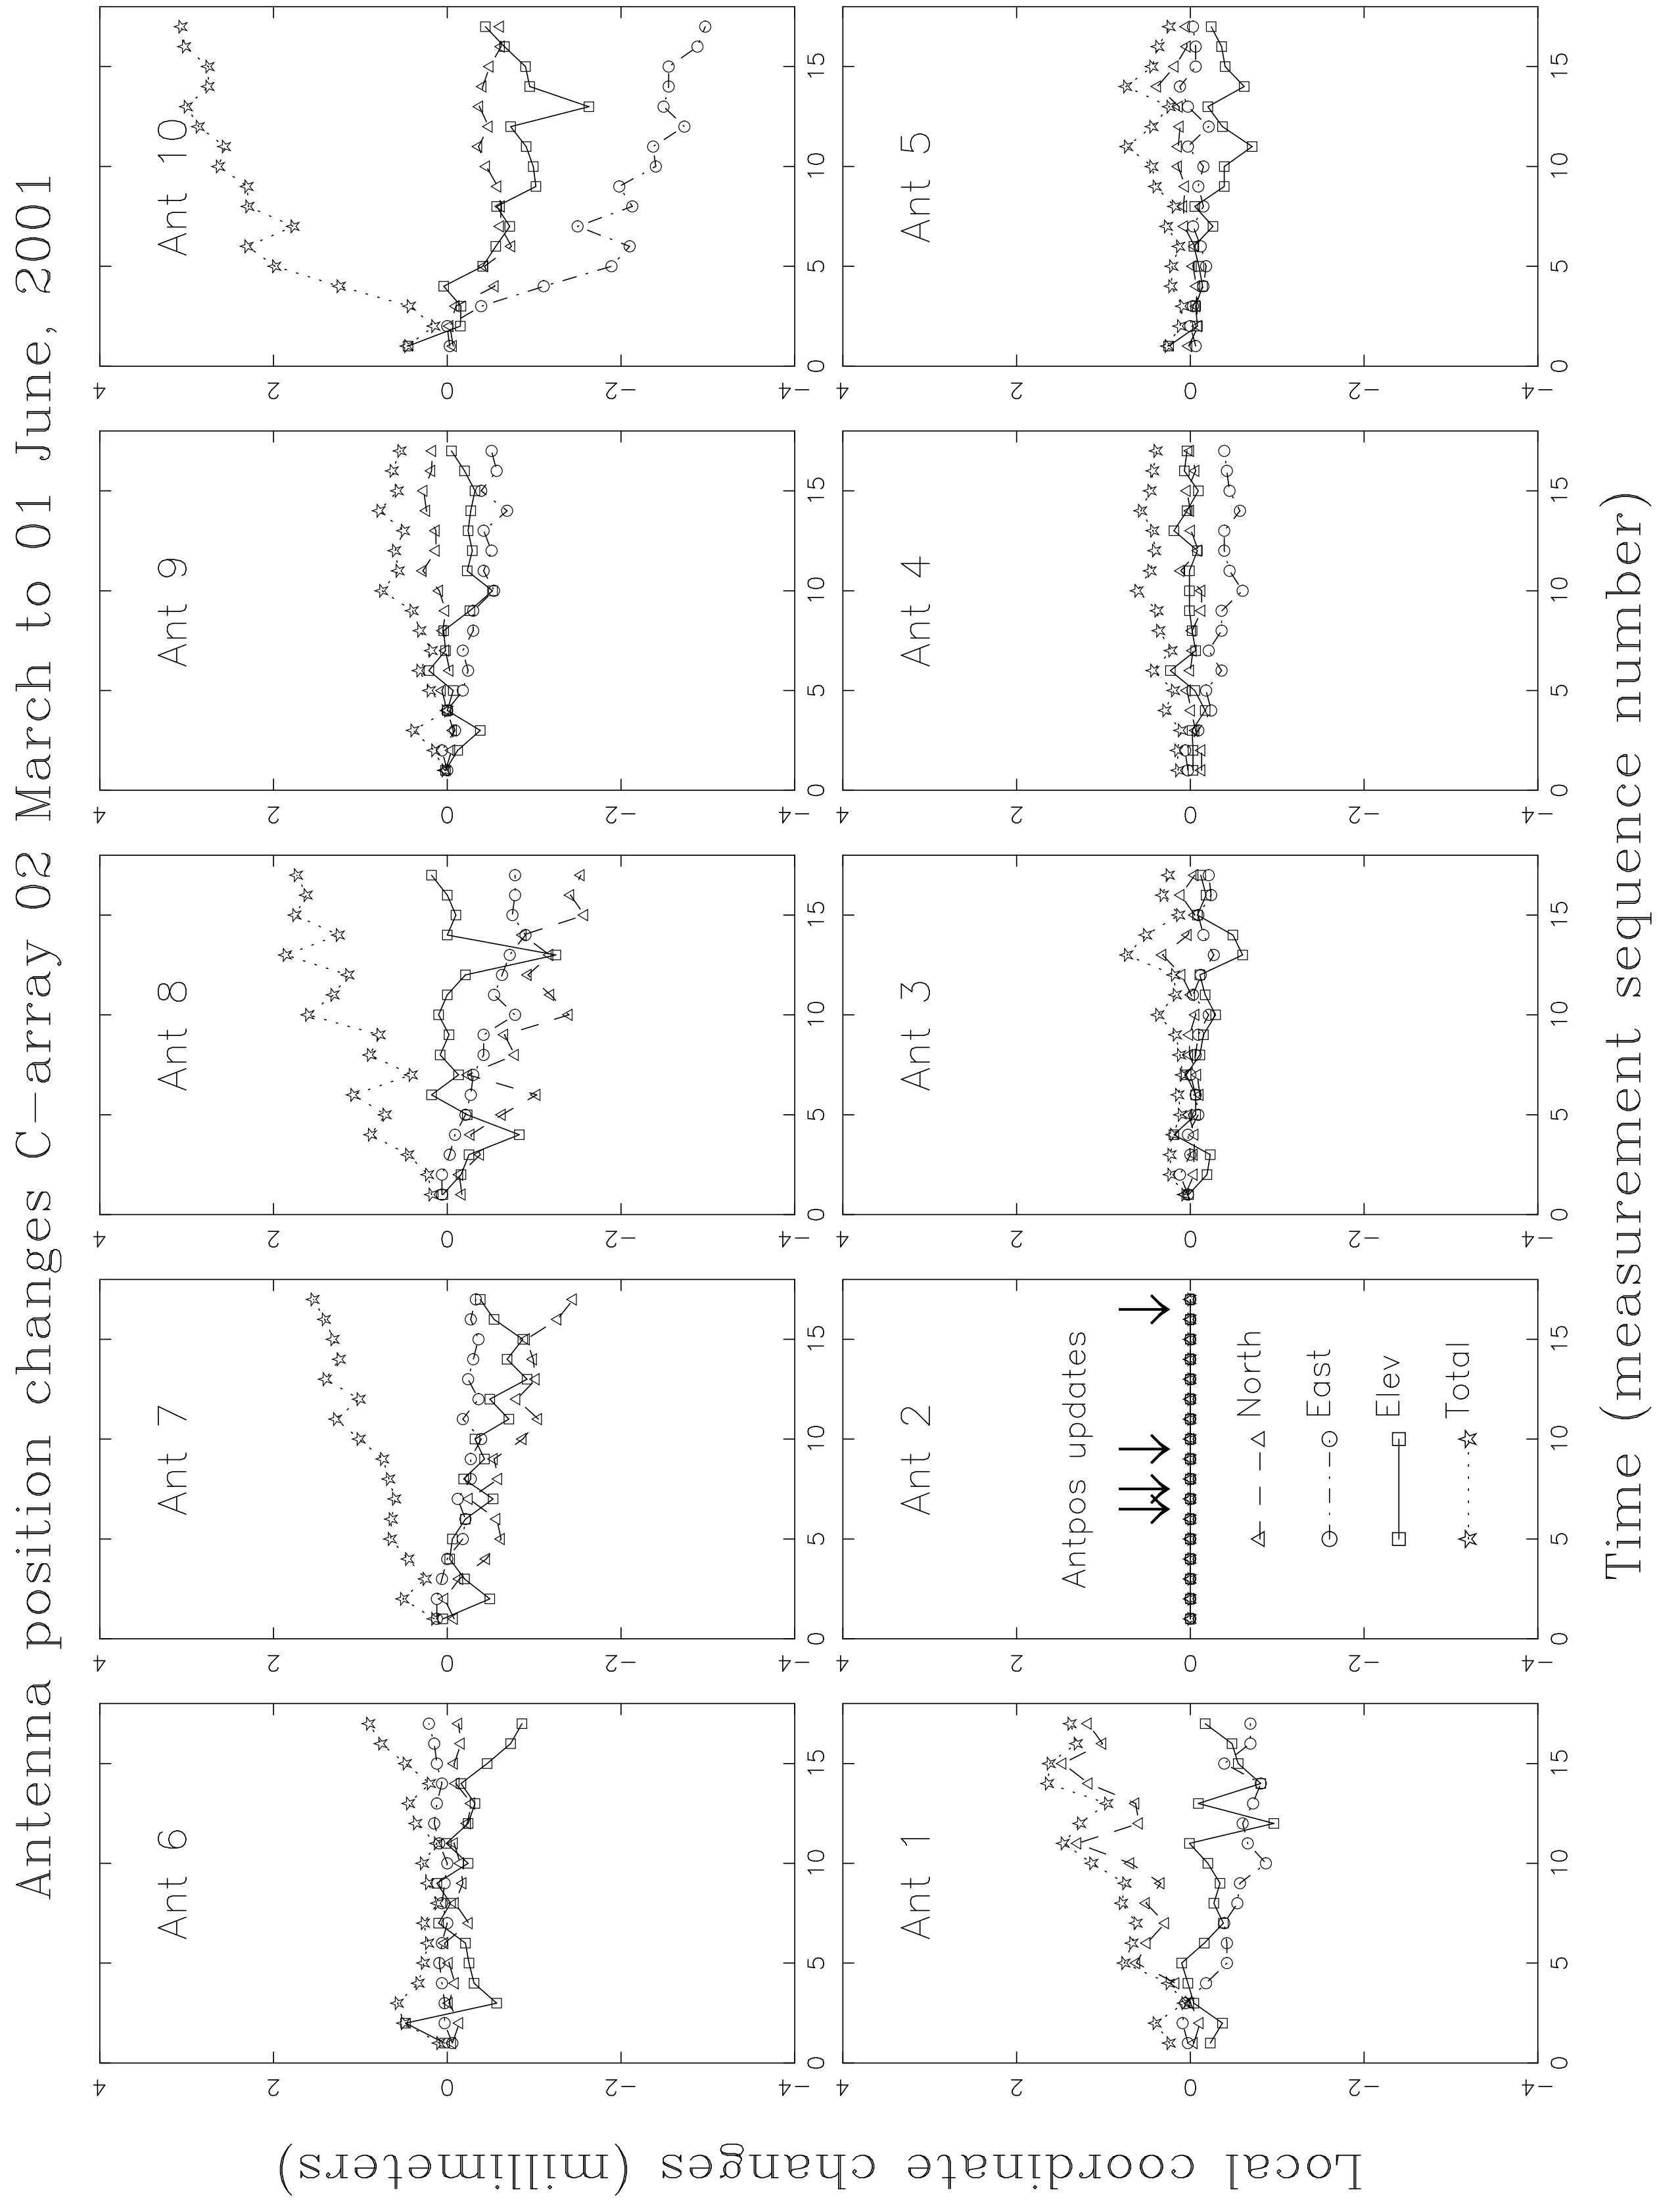
Fig. 1.— Antenna position changes in millimeters

Fig. 1 shows the antenna position changes following the original reconfiguration solution obtained at each epoch for which usable data was obtained from either baseline or flux calibration observations. While the antenna positions were updated on-line regularly to keep the phase transfer errors small, the changes plotted are relative to the original antenna positions in order to show the total change clearly. The times at which baseline updates were applied on-line are indicated in the reference antenna panel. The changes plotted in Fig. 1 have been transformed from geocentric coordinates (B1, B2, B3) in nanoseconds to local coordinates (North, East, Elevation) in millimeters. Each directional component change is shown individually, along with the total change in millimeters.

Most of the directional components changed monotonically with time in the 2001 C-array. In the horizontal plane (North and East) this is the case for all antennas. The changes were not all linear with time however. Ant 10 moved southwest by about 2mm in March, and then slowed to about 0.5mm per month in April and May. Almost all of Ant 10's southern motion occurred in March. Three of the four antennas with significant elevation changes (Ants 1, 7 and 10) dropped in height steadily until mid-May, then began to rise again. Ant 6 on the other hand was fairly stable until mid-May, at which time it began to drop by about 1mm over the next few weeks.

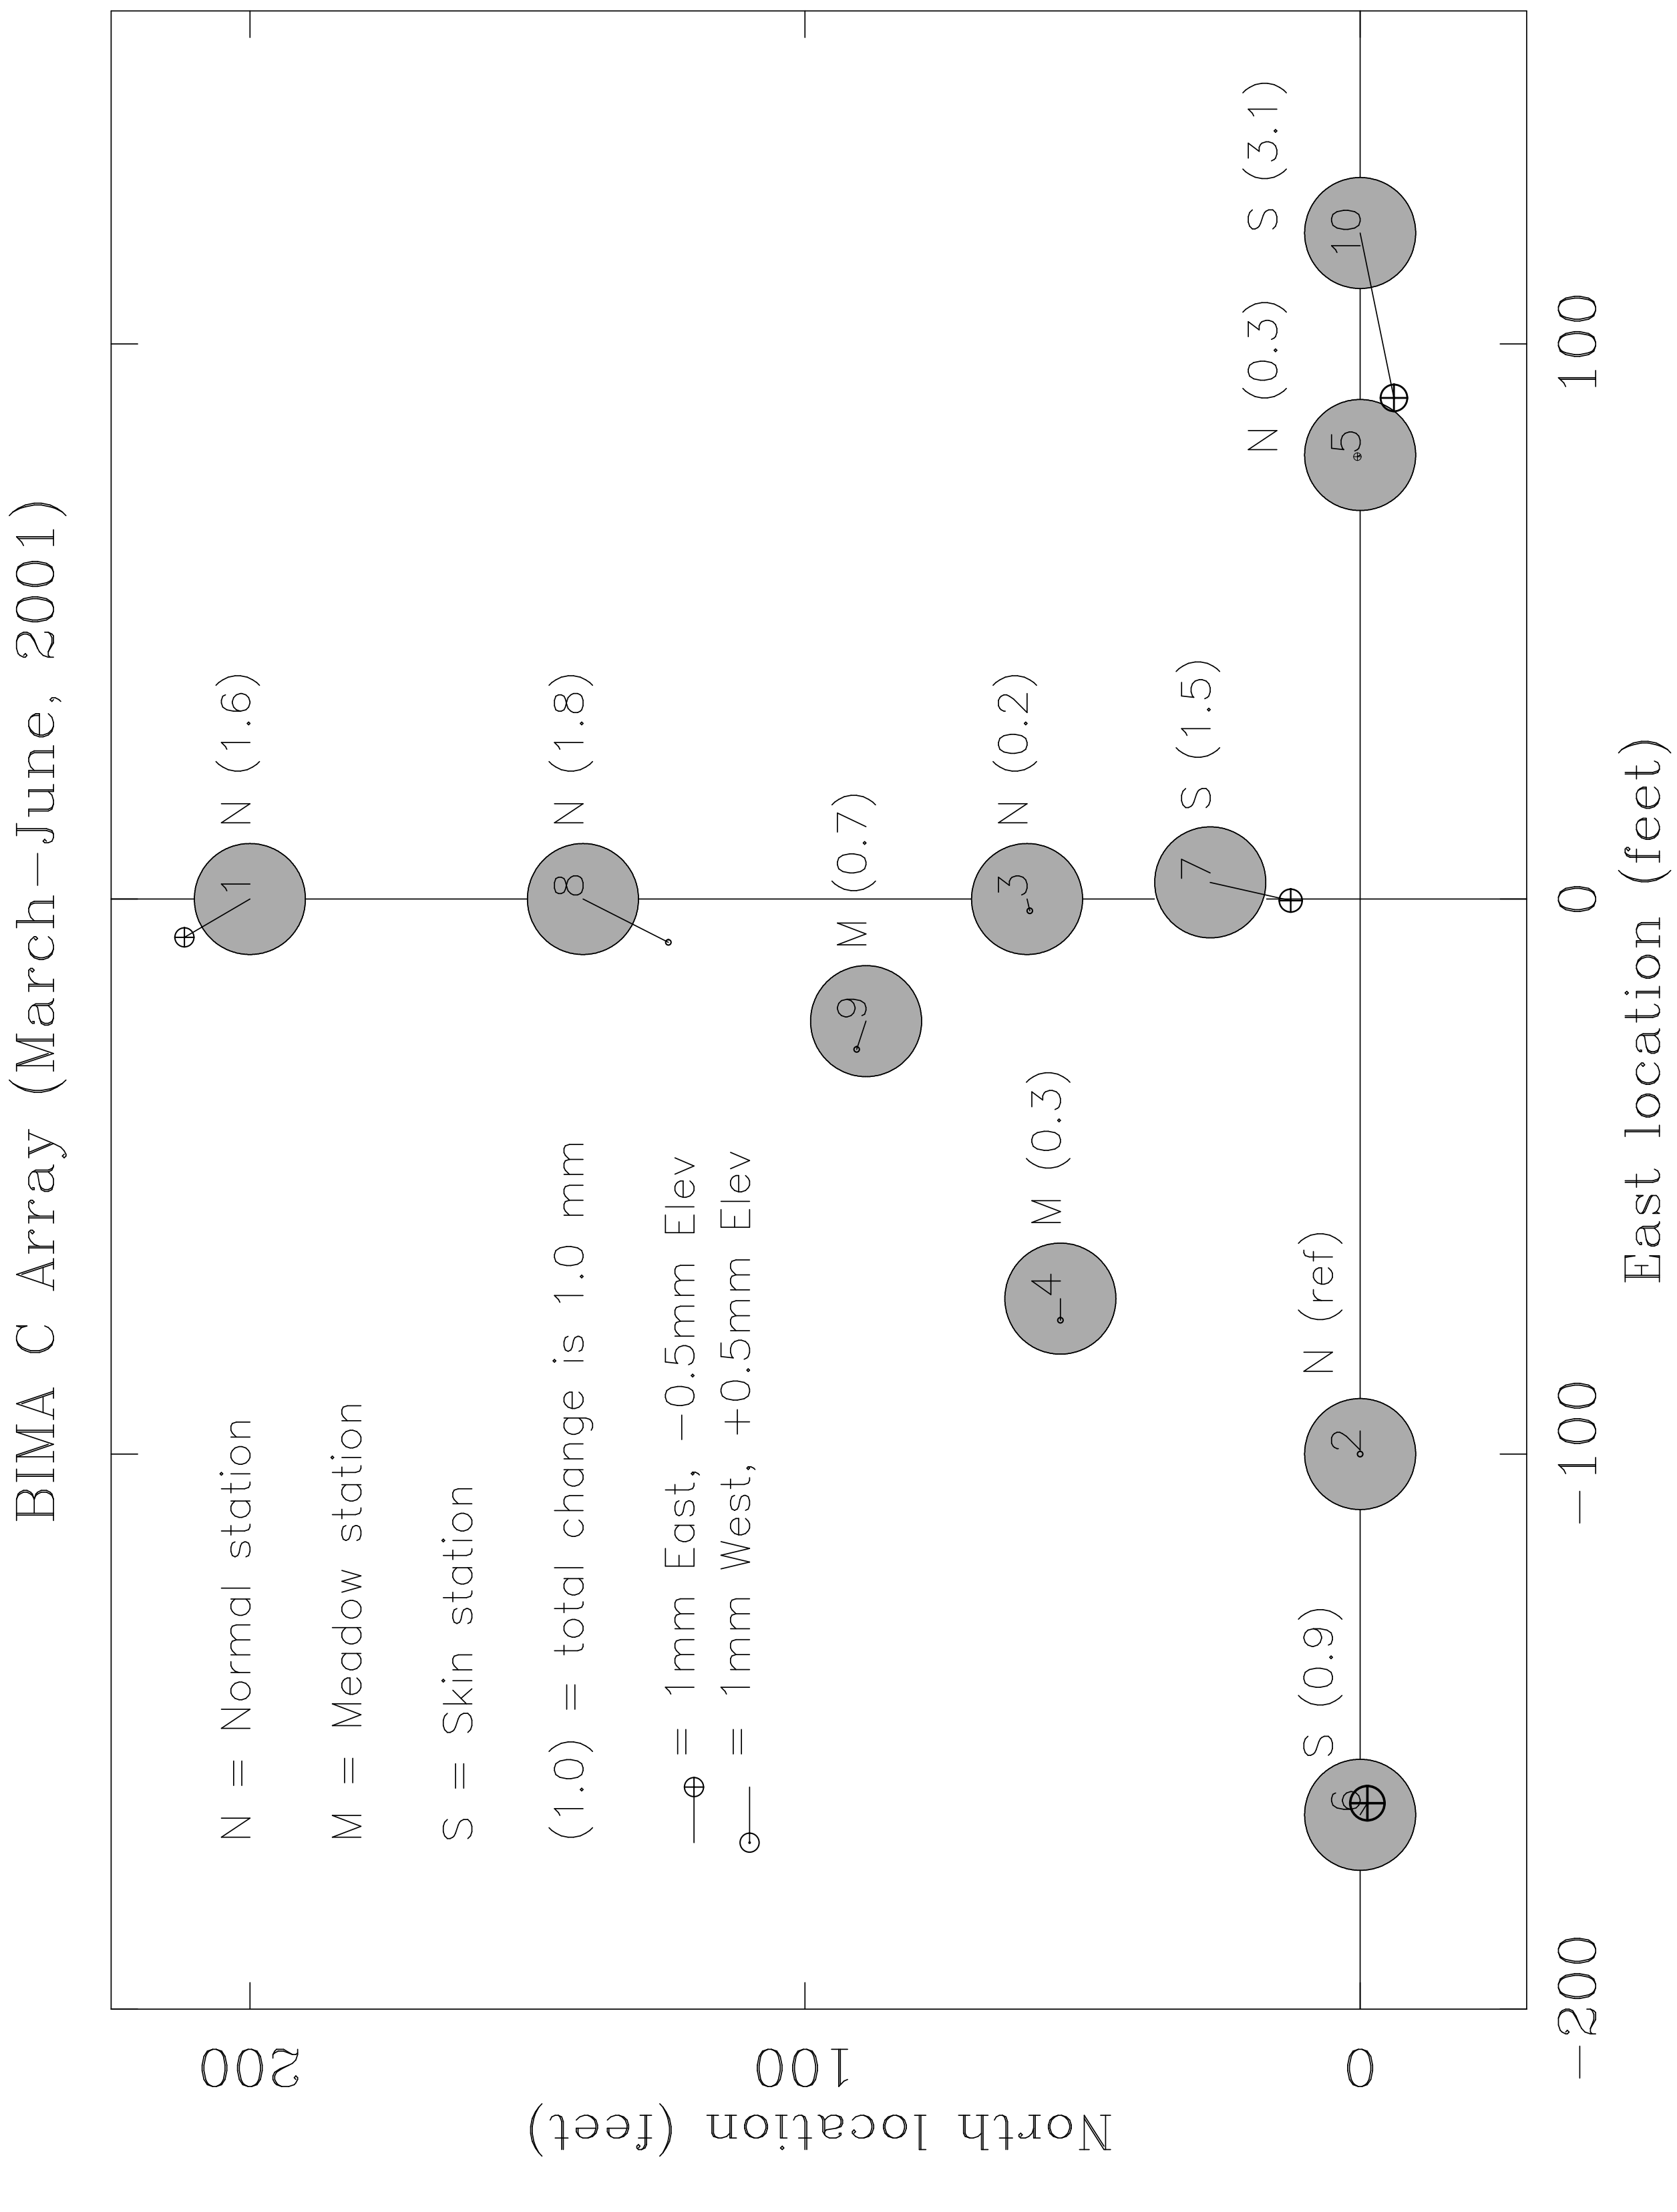
Fig. 2.— Antenna layout and measured motions

Fig. 2 shows the physical layout of antennas in the 2001 C-array. In this array five antennas are on "normal" stations, which have independent concrete piers tying the station to bedrock. Two antennas are on "meadow" stations, which are anchored to large concrete blocks embedded in soil. Three antennas are on "skin" stations. These sit directly on a concrete slab (the TEE) without any other foundation.

Fig. 2 also shows the total change in position measured between February and June for each antenna, along with a graphical representation of the horizontal and vertical movement. Position changes between 0.2mm (about 2 sigma) and 3mm were observed, with four antennas registering changes greater than 1mm. Ant 2 at normal station 100W was used as the reference antenna for this array.

Three antennas (3,4,5) did not move significantly relative to the reference antenna. Two of these were on normal stations and one was on a meadow station. Of the six antennas that did move by more than 0.3mm, four dropped in elevation by up to 1mm. The three antennas with the largest elevation changes were all located on skin stations. The five antennas with significant horizontal changes moved in a northwest or southwest direction. The two northernmost antennas moved about the same distance west (0.7mm), but Ant 1 moved north and Ant 8 moved south for a total relative position change of 3mm. Both of these antennas were located on normal stations.
